THE MALDEN SURVEY

A REPORT ON THE CHURCH PLANTS OF
A TYPICAL CITY, SHOWING THE USE
OF THE INTERCHURCH WORLD MOVE-
MENT SCORE CARD AND STANDARDS
FOR RATING CITY CHURCH PLANTS

Copyright 1920 by the
Interchurch World Movement
of North America

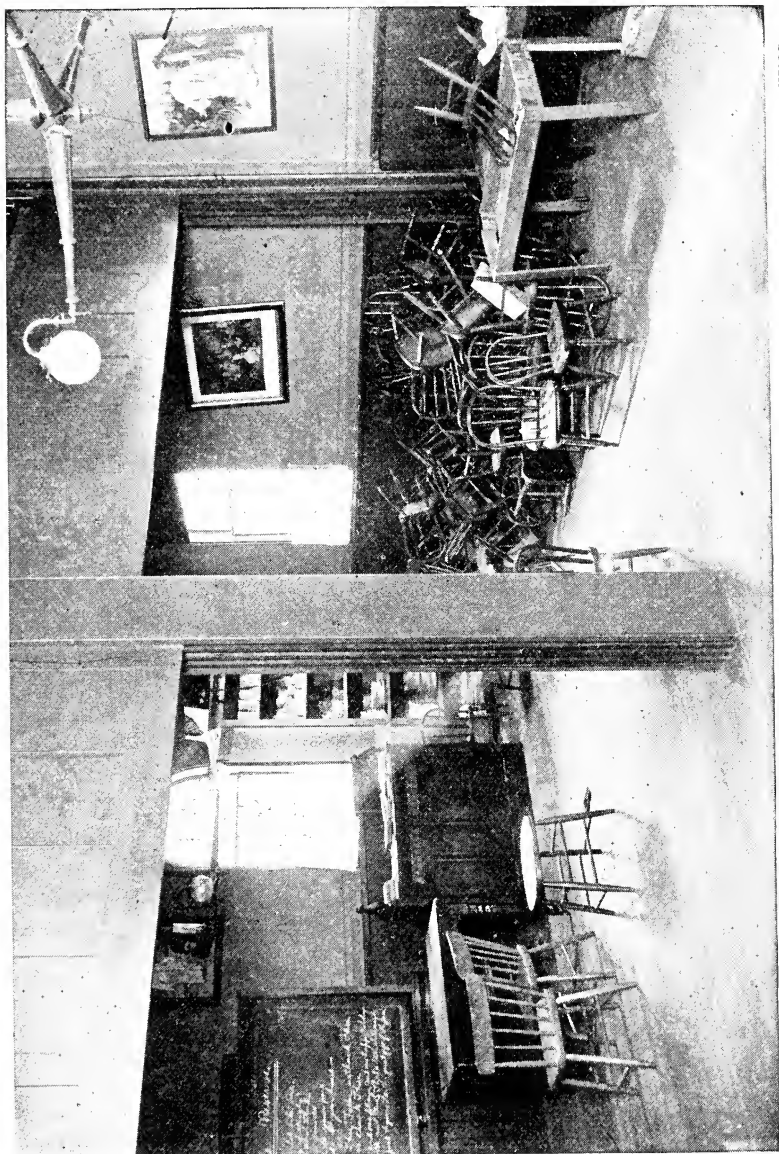
ILLUSTRATION 81. CLASS ROOMS IN THE MAPLEWOOD BAPTIST CHURCH. NOTE THE DEFECTIVE LIGHTING, THE POOR EQUIPMENT AND THE MAKESHIFT SAND BOX. TEACHING BECOMES DIFFICULT UNDER THESE CONDITIONS

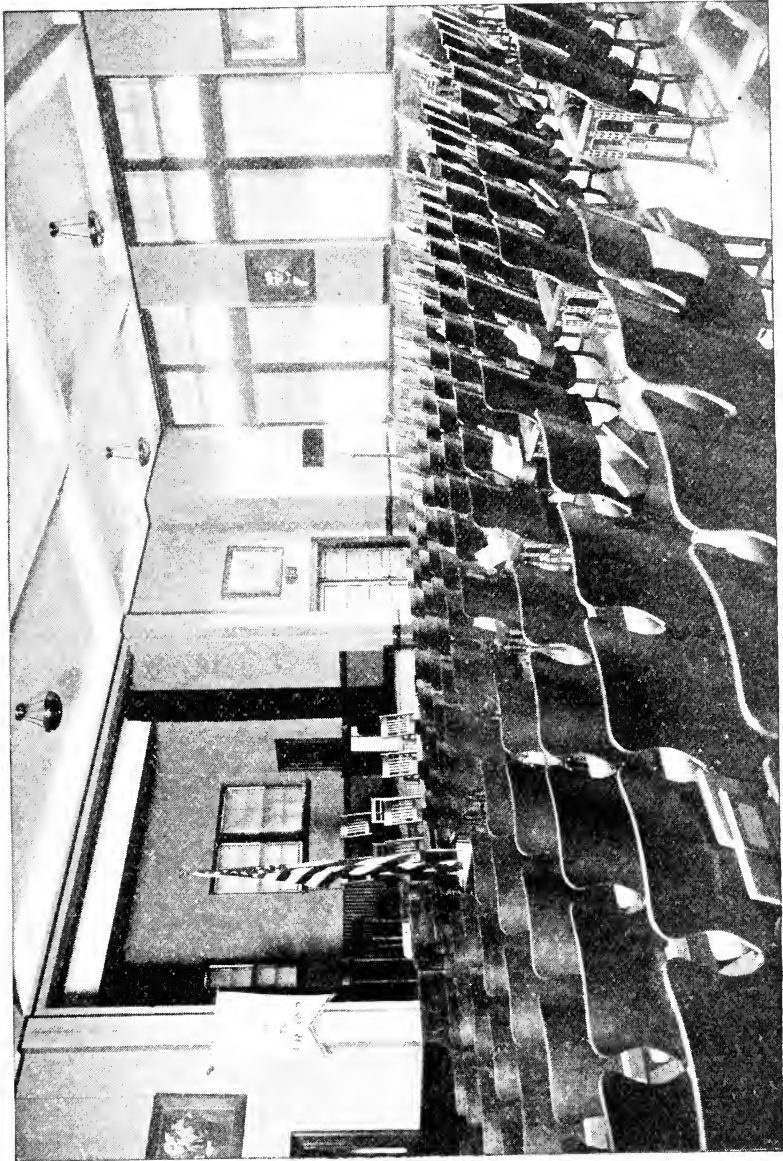
ILLUSTRATION 82. THE ADULT ASSEMBLY OF THE FIRST BAPTIST PARISH HOUSE. NOTE THE COMFORTABLE SEATS, THE WELL SELECTED PICTURES AND THE INDIRECT ARTIFICIAL LIGHTING. UNFORTUNATELY, NATURAL LIGHT COMES FROM THE RIGHT ONLY

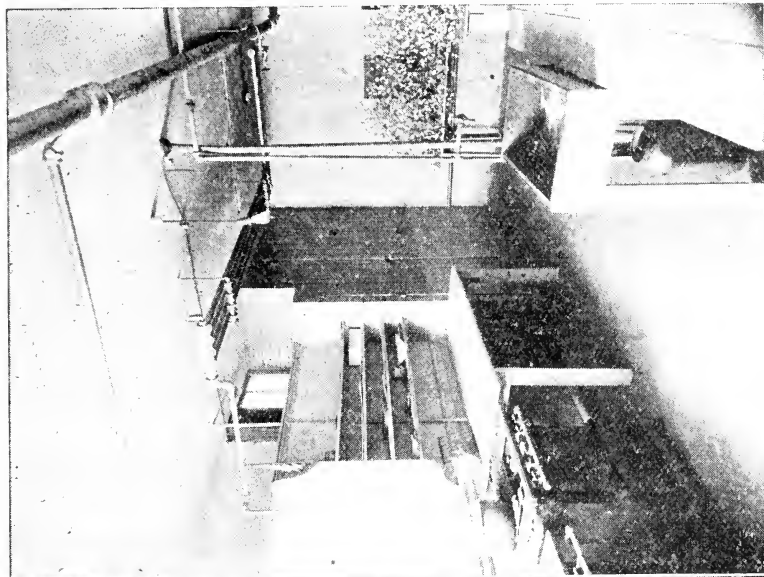
ILLUSTRATION 85. THE SMALL, INADEQUATE KITCHEN OF THE FAULKNER METHODIST CHURCH

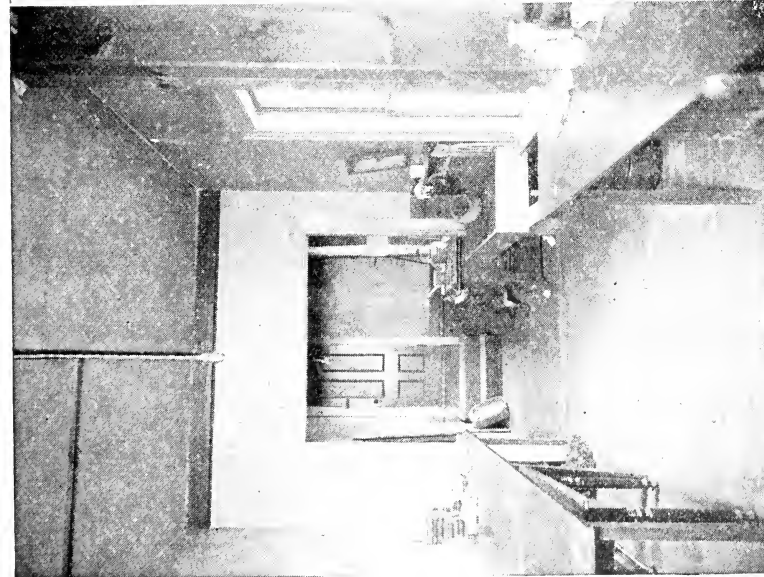
ILLUSTRATION 84. THE POORLY EQUIPPED KITCHEN OF THE LINDEN CONGREGATIONAL CHURCH
